**Flood Control Project Maintenance
Levee Inspections**
LMA District Cover Sheet
Spring 2019 Levee Inspection Results

Reclamation District No. 0404 Boggs

Spring 2019 Levee Inspection Results

| Waterway | Bank | Unit Miles |
|---|---|---|
| Unit No. 01 San Joaquin River | Right | 2.35 |

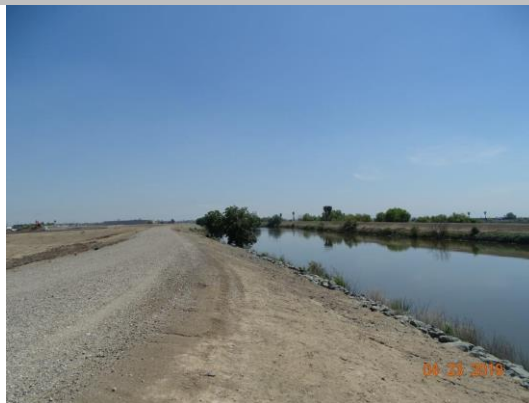
Photo 1 of 1 : SP_2019_RD0404_305_30_20190430_00058.jpg

Typical view of vegetation on waterside slope. (Spring 2019)

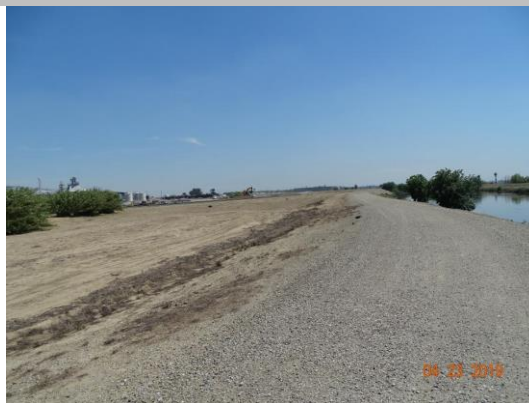
Photo 1 of 1 : SP_2019_RD0404_305_28_20190430_00059.jpg

Typical view of vegetation on landside slope. (Spring 2019)

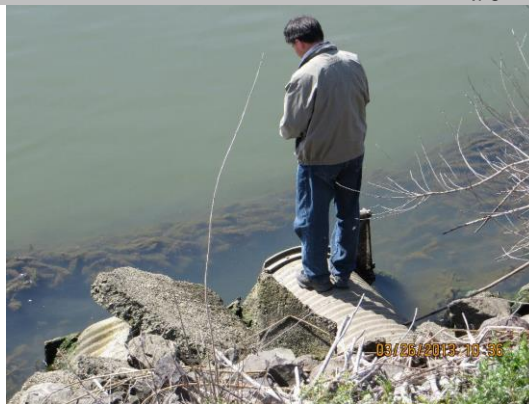
Photo 2 of 3 : UCIP_SP_2019_53346_20081.jpg

WS- left CM pipe with missing flap gate

| UCIP Comments: 10/2/2018 Crossing shows no sign of pipe or levee integrity issues; down grading to Non-Urgent (D. Sanoski - DWR UCIP).11/29/2016 Flap gates still missing. Pipe open on WS. Could not locate on LS. (K. Fazel - UCIP)03/26/2013 Flap gate missing from WS toe. (P. Amatya - DWR) | | | | | | |

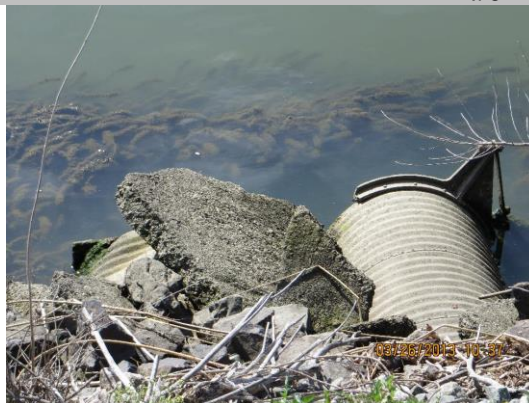
Photo 3 of 3 : UCIP_SP_2019_53346_20080.jpg

WS- closer look at left CM pipe with missing flap gate

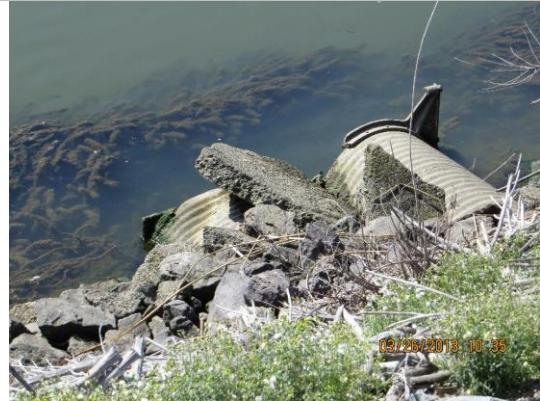
Photo 1 of 3 : UCIP_SP_2019_53347_20086.jpg

WS- two CM pipes with damaged flap gates

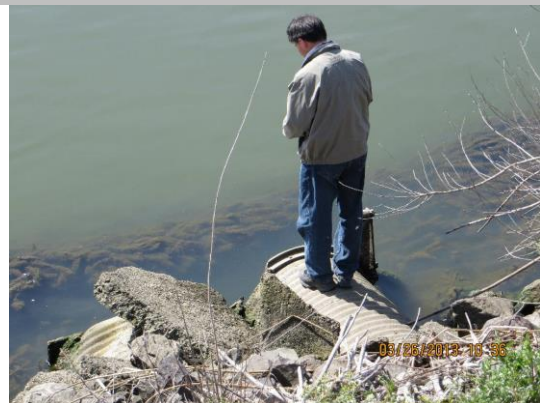
Photo 2 of 3 : UCIP_SP_2019_53347_20085.jpg

WS- right CM pipe with damaged flap gate

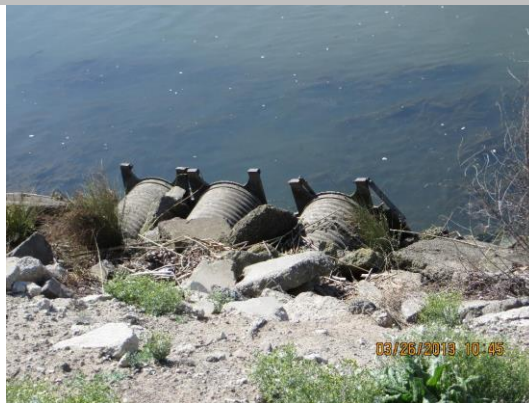
Photo 3 of 3 : UCIP_SP_2019_51168_20042.jpg

WS- CM pipes with damaged flap gates

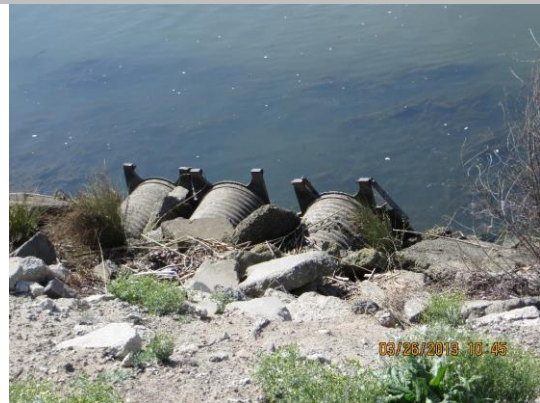
Photo 2 of 3 : UCIP_SP_2019_53348_20046.jpg

WS- CM pipes and damaged flap gates

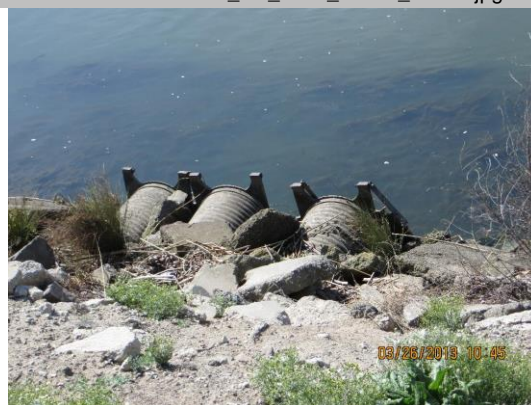
Photo 2 of 3 : UCIP_SP_2019_53349_20053.jpg

WS- CM pipes with damaged flap gates

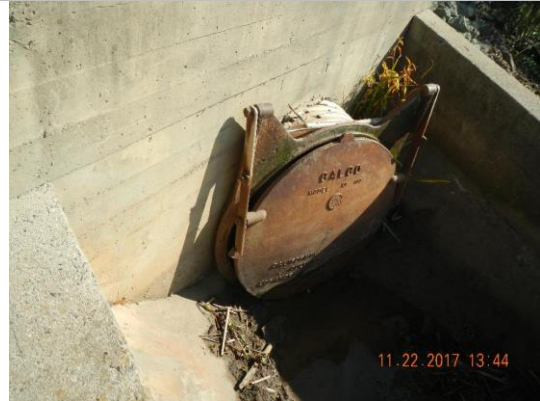
Photo 1 of 3 : UCIP_SP_2019_53532_77527.jpg

FS_ID:53532
DS_ID:17945
EP_NO: N/A
Repair Type: No Action Needed
Crossing Status: Found
UCIP Comments: 11/22/2017 Received updated photo from DWR levee inspector D. Torres showing gate has been cleared of sediment to allow operation of the gate on the WS. Crossing has been downgraded from Urgent to No Action Needed based on the 2016 photos and the most current photo. Recommend coordinating with City of Stockton to determine as-builts, CVFPB permit, and date of last internal integrity inspection completed for this crossing. (DWR UCIP - O. Magana)

WS view: WS gate cleared allowing proper operation of gate.

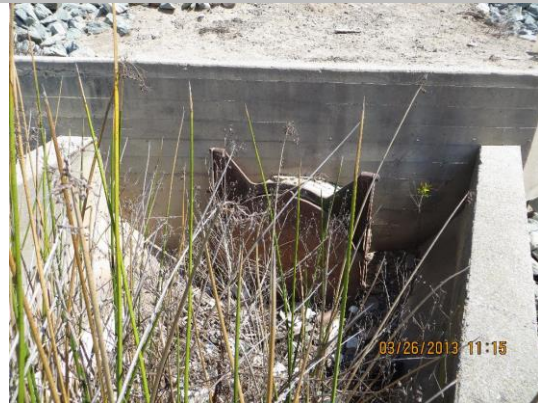
Photo 3 of 3 : UCIP_SP_2019_53532_19961.jpg

11/29/2016 Flap gate still buried with sediment on WS. Requires clearing. (K. Fazel - UCIP)03/26/2013 Partially buried flap gate (P. Amatya - DWR)
FIELD_STRUCT_DESC: 42-inch corrugated metal drainage discharge pipe, 18 feet below the crown. Flap gate, concrete headwall, and spillway on the waterside (WS). Pump house on the landside (LS). Abandoned concrete headwall, power pole, and two wooden piles found on the LS. This drainage pipe likely belongs to the City of Stockton.
[Additional Reference(s): DWR Levee Log, 2006. USACE San Joaquin O&M Manual 1, March 1963, (HLM 0.78)].
FS Date: 11/22/2017

WS- Debris and vegetation blocking CM drainage pipe

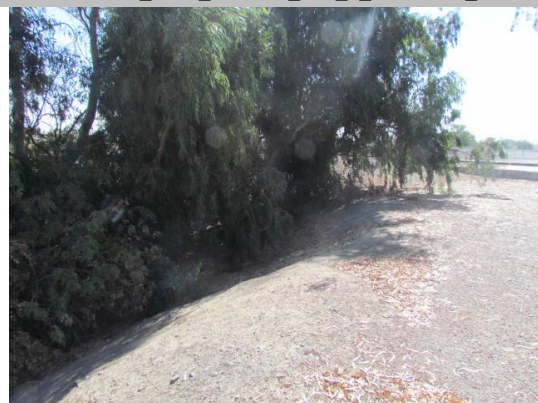
Photo 1 of 1 : SP_2019_RD0404_305_8_20190313_00004.jpg

Looking southeast at dense trees on landward slope and toe.

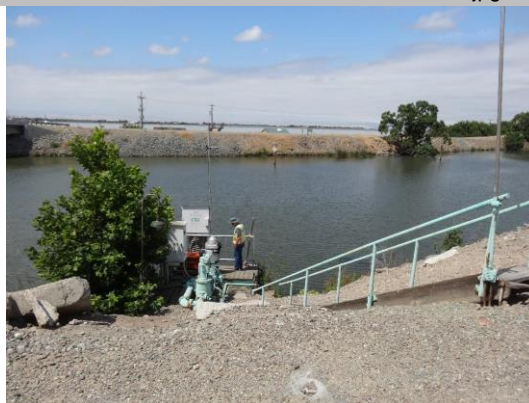
Photo 2 of 3 : UCIP_SP_2019_46801_74747.jpg

WS view: pump with shutoff valves, headwall, stairs visible. Concrete debris along WS slope.

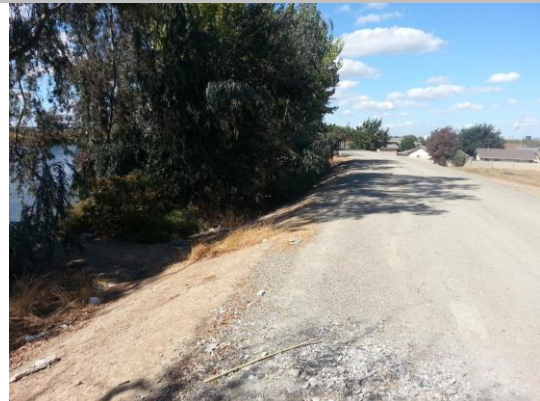
Photo 1 of 1 : SP_2019_RD0404_305_100_20190313_00020.jpg

Looking northwest at untrimmed trees on waterward slope.

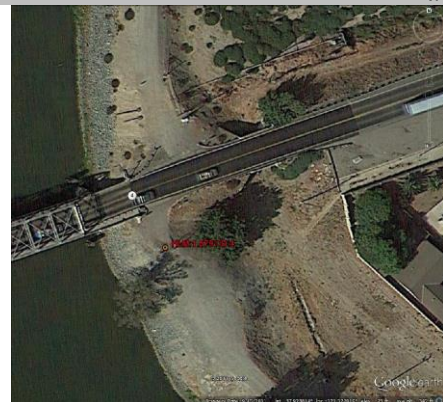
Photo 1 of 1 : UCIP_SP_2019_12386_20062.jpg

Aerial Photo @HLM=1.5791: No sign posts/markers found.

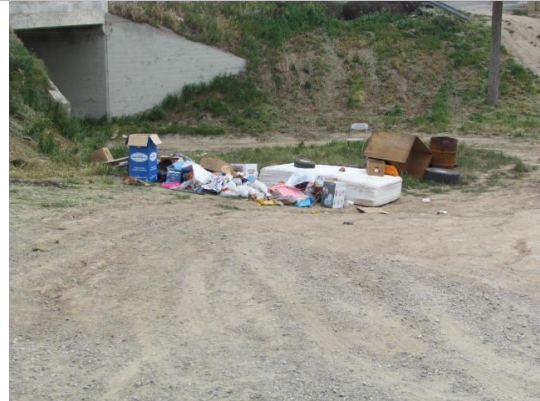
Photo 1 of 1 : SP_2019_RD0404_305_36_20190313_00017.jpg

Looking east at garbage on landward slope and toe.

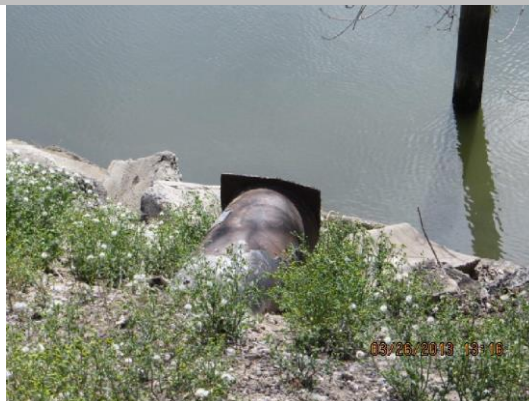
Photo 3 of 3 : UCIP_SP_2019_40487_20065.jpg

WS- abandoned steel pipe capped with steel plate.

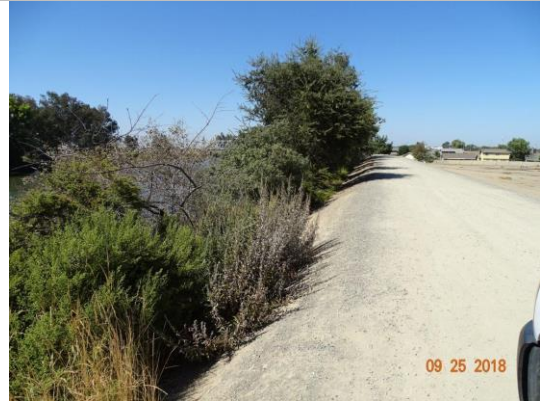
Photo 2 of 2 : SP_2019_RD0404_305_23_20190313_00012.jpg

Looking northwest at overgrown site on waterward slope. (Fall 2018)

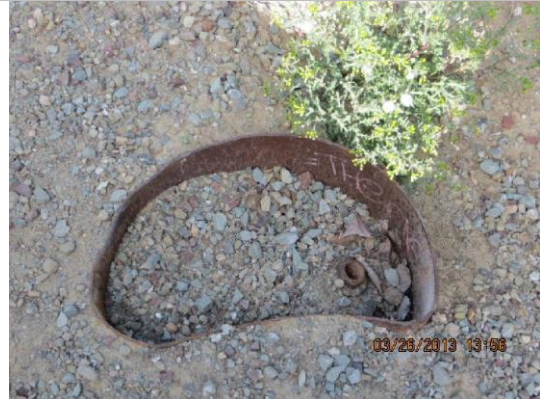
Photo 3 of 3 : UCIP_SP_2019_40797_20071.jpg

LS- damaged and obstructed siphon breaker on levee shoulder.

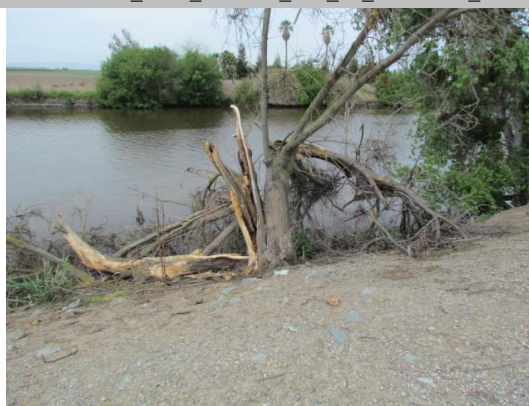
Photo 1 of 1 : SP_2019_RD0404_305_33_20190313_00016.jpg

Looking west at dead tree on waterward slope.

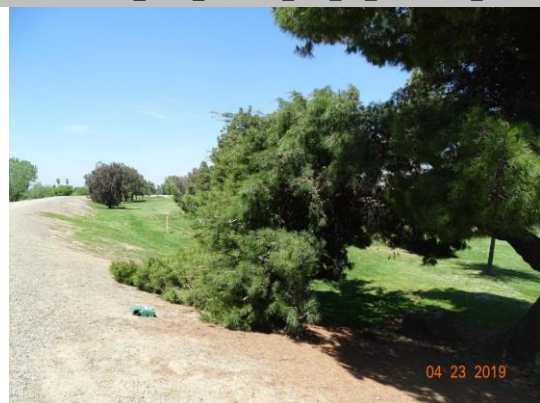
Photo 1 of 1 : SP_2019_RD0404_305_31_20190430_00060.jpg

Broken large tree limb on landside slope, District Engineer is aware and has scheduled removal. (Spring 2019)

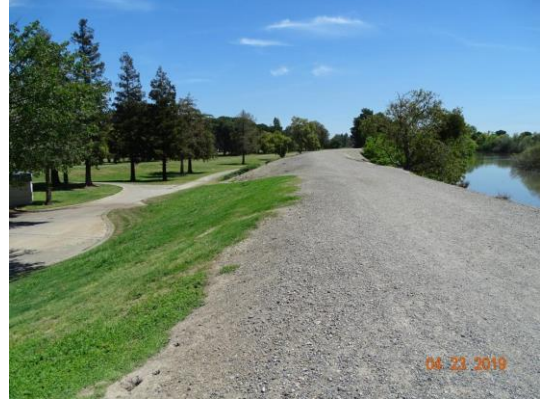
Photo 1 of 1 : SP_2019_RD0404_306_9_20190522_00029.jpg

Typical view of vegetation on landside slope. (Spring 2019)

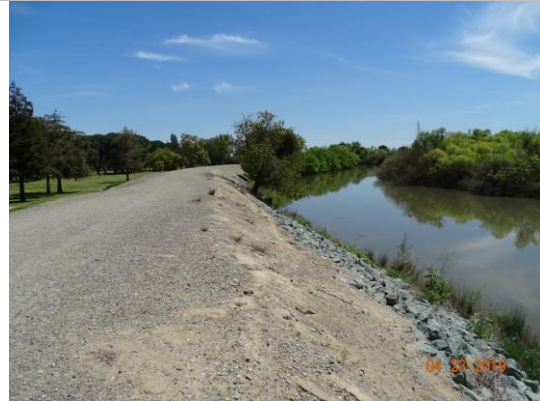
Photo 1 of 1 : SP_2019_RD0404_306_10_20190522_00028.jpg

Typical view of vegetation on waterside slope. (Spring 2019)

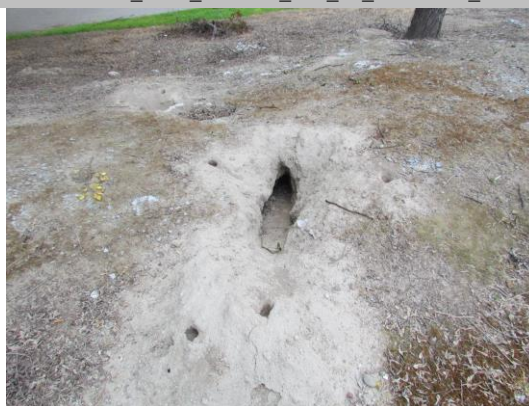
Photo 1 of 3 : SP_2019_RD0404_306_11_20190313_00001.jpg

Looking east at large rodent hole on landward slope.

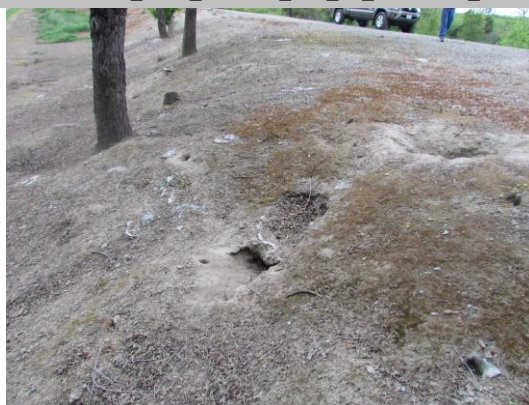
Photo 2 of 3 : SP_2019_RD0404_306_11_20190313_00002.jpg

Looking southwest at several rodent holes on landward slope.

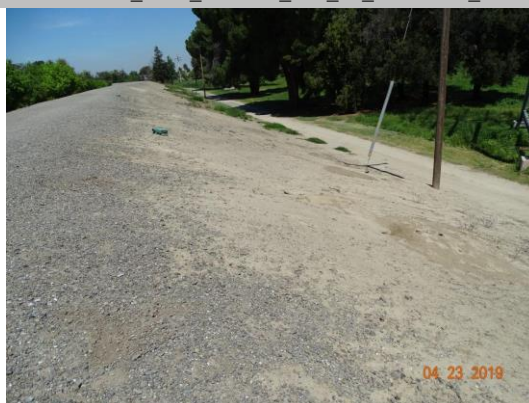
Photo 3 of 3 : SP_2019_RD0404_306_11_20190522_00027.jpg

View of landside slope with multiple rodent holes. Animal control/bait program not effective. (Spring 2019)

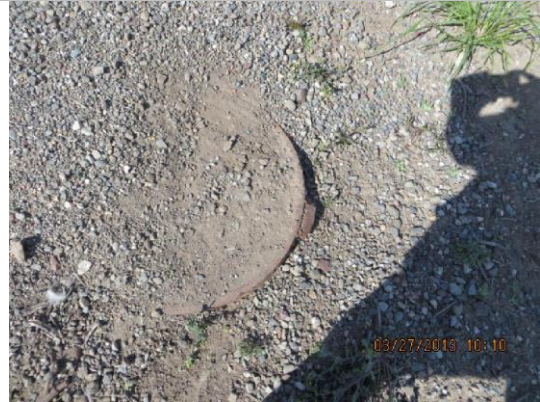
Photo 2 of 3 : UCIP_SP_2019_10908_18181.jpg

WS- damaged, obstructed and buried siphon breaker

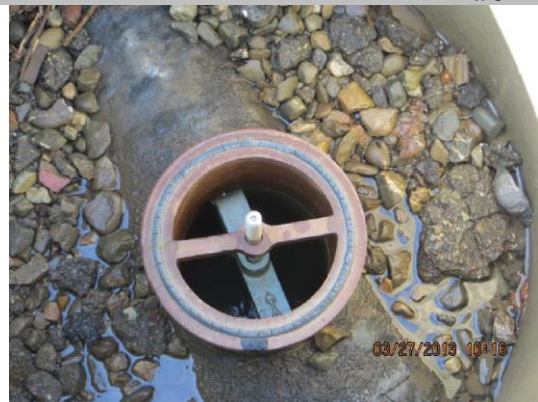
Photo 1 of 3 : UCIP_SP_2019_10945_18248.jpg

WS- siphon breaker without cap in concrete riser
